Manhole Inspection Summary

Manhole # S25WW1001MH

Location Address: **5207 ROALND AVE**

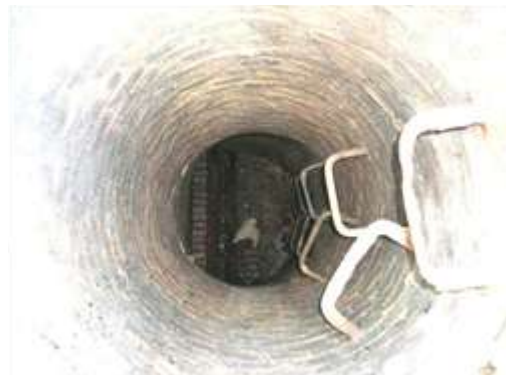
Top View

Corroded steps. Bench debris.

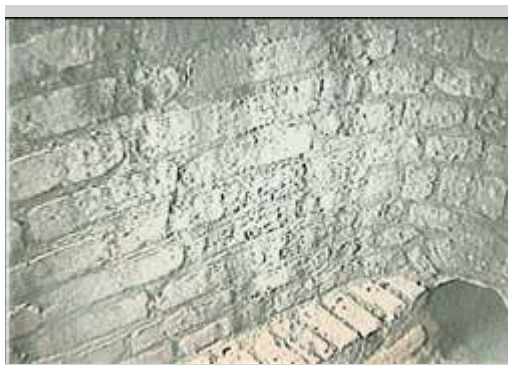
Defect

Barrel infiltration.

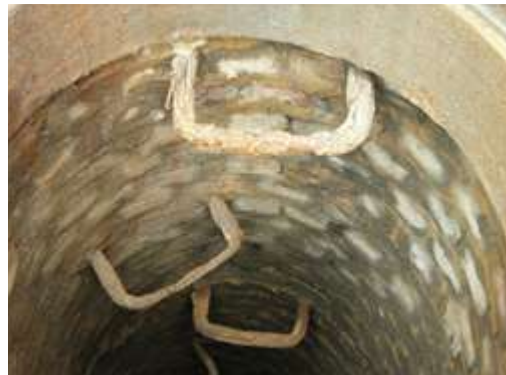
Defect

Frame leaks. Corroded steps. Adjustment and Corbel infiltration.

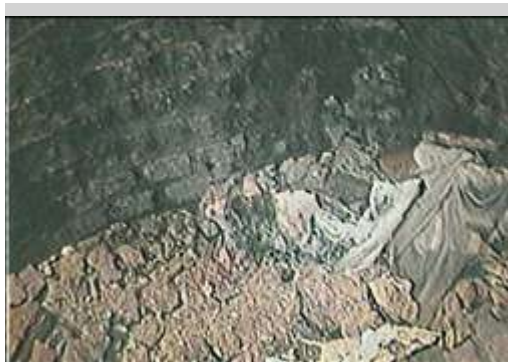
Defect

Evidence of surcharge - Bench debris.

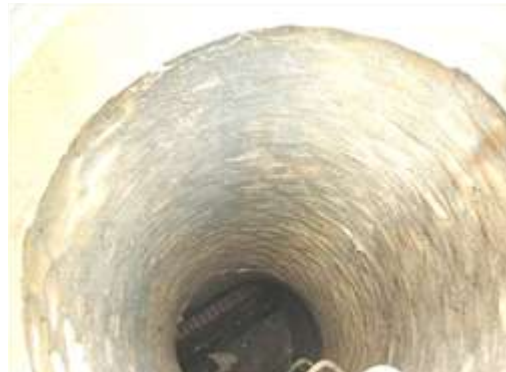
Defect

Frame leaks. Adjustment infiltration.

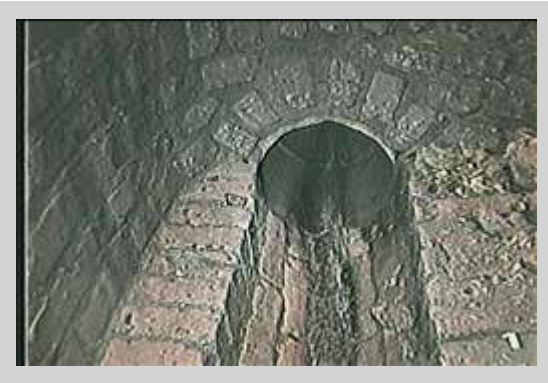
10 in. Circular Gravity Sewer Pipe Out @ 12 O'Clock

Channel deterioration.

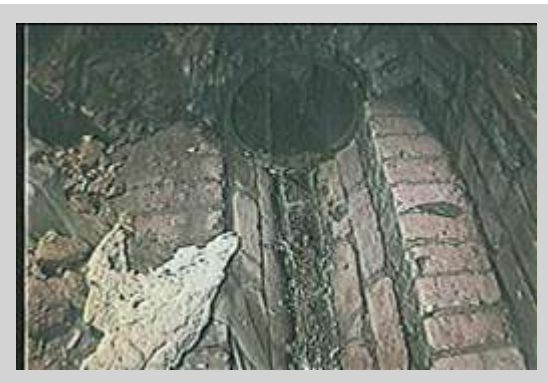
10 in. Circular Gravity Sewer Pipe In @ 6 O'Clock

Infiltration: **Evidence** Pipe Seal Cond: **Unknown**
